BEAVER RUN DAM  
NDI No. Pa. - 484

PHASE I INSPECTION REPORT  
NATIONAL DAM INSPECTION PROGRAM

Beaver Run Dam, NDI Number PA-484. Ohio River Basin, Beaver Run, Westmoreland County, Pennsylvania. Phase I Inspection Report.

11 May 1978 (visual inspection)

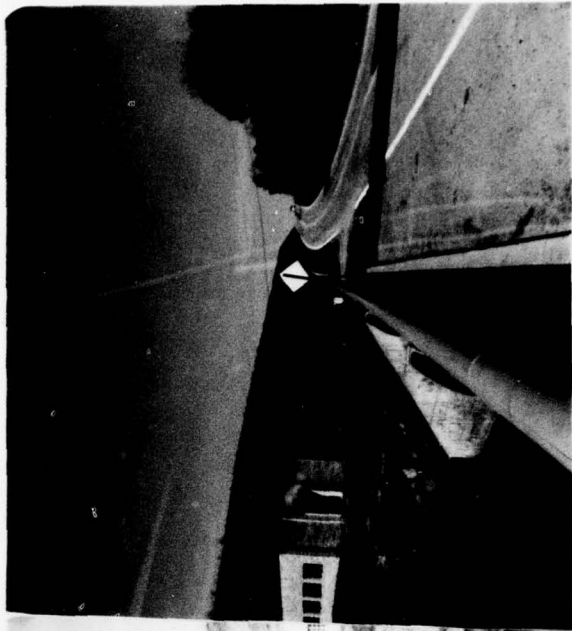
PHOTOGRAPH 2 Panoramic view of the downstream slope of the Beaver Run Dam. The emergency spillway section (low spot in road at Route 380) can be seen in the right portion of the photograph.

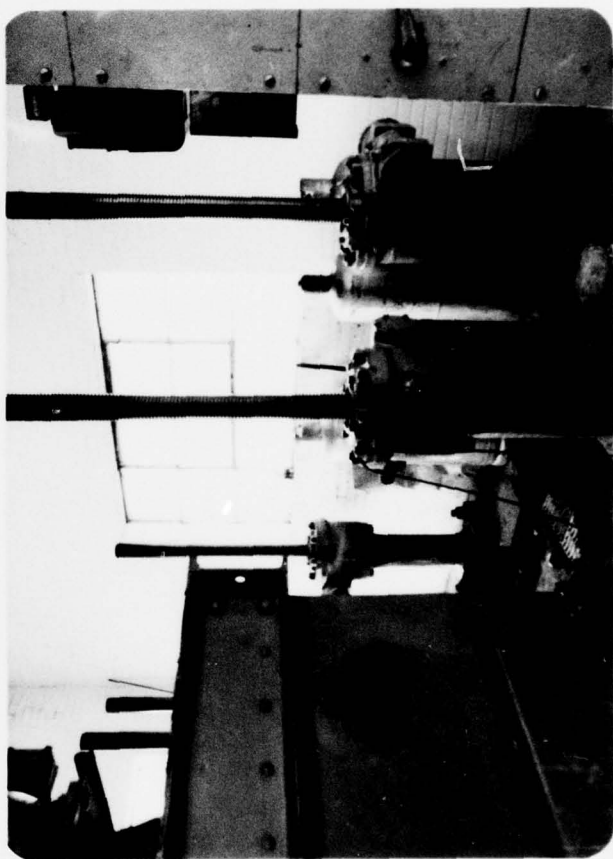
2. Gate House. The general condition of the gate house, access bridge, and valves appeared satisfactory. According to a representative of the Water Authority, the valves are in good working order and are periodically maintained. Three valves located within the gate house allow for the removal of water from different elevations within the reservoir. This water discharges into two 42-inch cast iron pipes which pass through the dam beneath the 10-foot diameter extension to the spillway (see Figure 6).

PHOTOGRAPH 5 View of the three main valves in the gate house at the Beaver Run Facility. Numbers on each of the gate screws depict the elevation at which each of the particular gates can be opened to obtain water from different levels.

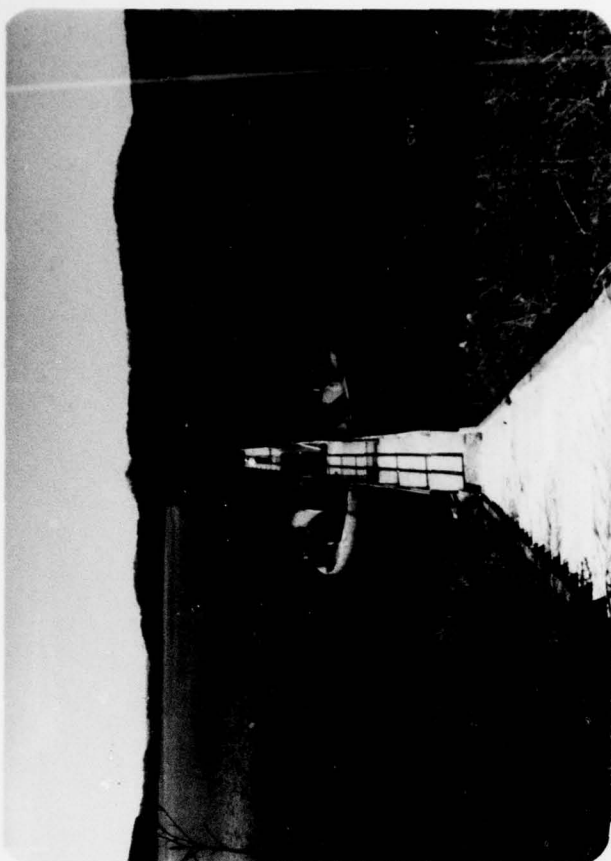
1. Spillway. The "Morning Glory" spillway appeared to be in satisfactory condition. Efflorescence was observed along the cold joint resulting from raising the spillway in 1962. Reportedly some repair work was performed on the impact block in the spillway, however, access to this portion of the outlet structure could not be attained hence we were not able to observe this remedial work during our investigation.

PHOTOGRAPH 4 View of the Morning Glory spillway which is the primary outlet works at the facility. The gate house is shown in the background.

a. It is recommended that the owner retain the services of a registered professional engineer, experienced in hydraulic and hydrologic design, to evaluate the condition of the spillway outlet and to make any modifications deemed necessary to provide for safe and unattended flow through the outlet system.

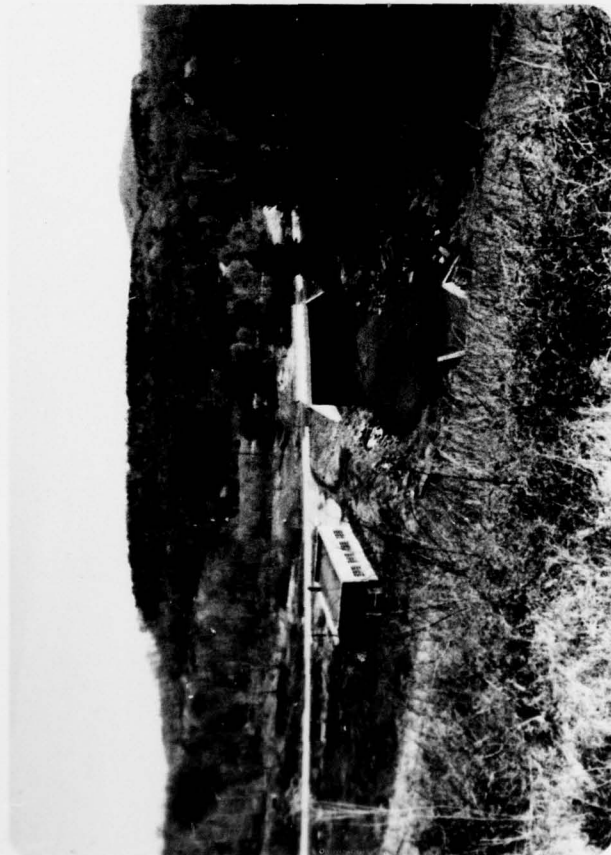
PHOTOGRAPH 3 View looking downstream from the crest of Beaver Run embankment showing a bridge on Route 380 which is located ~400 feet downstream of the dam. Note the valley downstream of the dam.

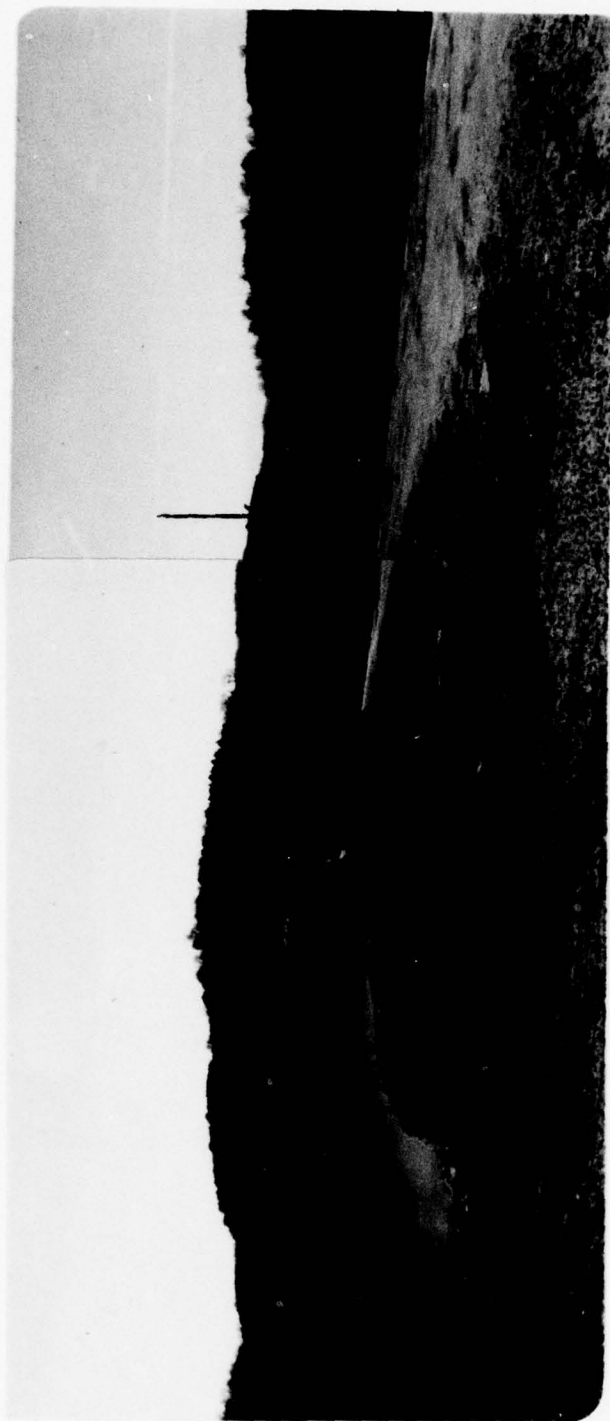
Just prior to the confluence with the Kiskiminetas River, Beaver Run passes through the community of Paulton, Pennsylvania. Numerous homes are located near the banks of the stream at this point. There are also at least two dwellings located on the hillside about 1000 feet downstream and north of the dam. At least 12 dwellings could conceivably be within the influence of a flood that would result from a breach of the Beaver Run embankment, consequently, a high hazard rating was given to the facility.

PHOTOGRAPH 8      Panorama view of the downstream area from  
Beaver Run Reservoir. On the far left a  
few homes can be seen. The embankment is  
shown in the center of the panorama (see  
arrow).

d. It is also recommended that a warning system be developed to allow for the safe evacuation of downstream inhabitants in the event of an unusually heavy rainfall.
